Debris/Ice/TPS Assessment And Integrated Photographic Analysis For Shuttle Mission STS-52

December 1992

DEBRIS/ICE/TPS ASSESSMENT
AND
PHOTOGRAPHIC ANALYSIS
OF
SHUTTLE MISSION STS-52

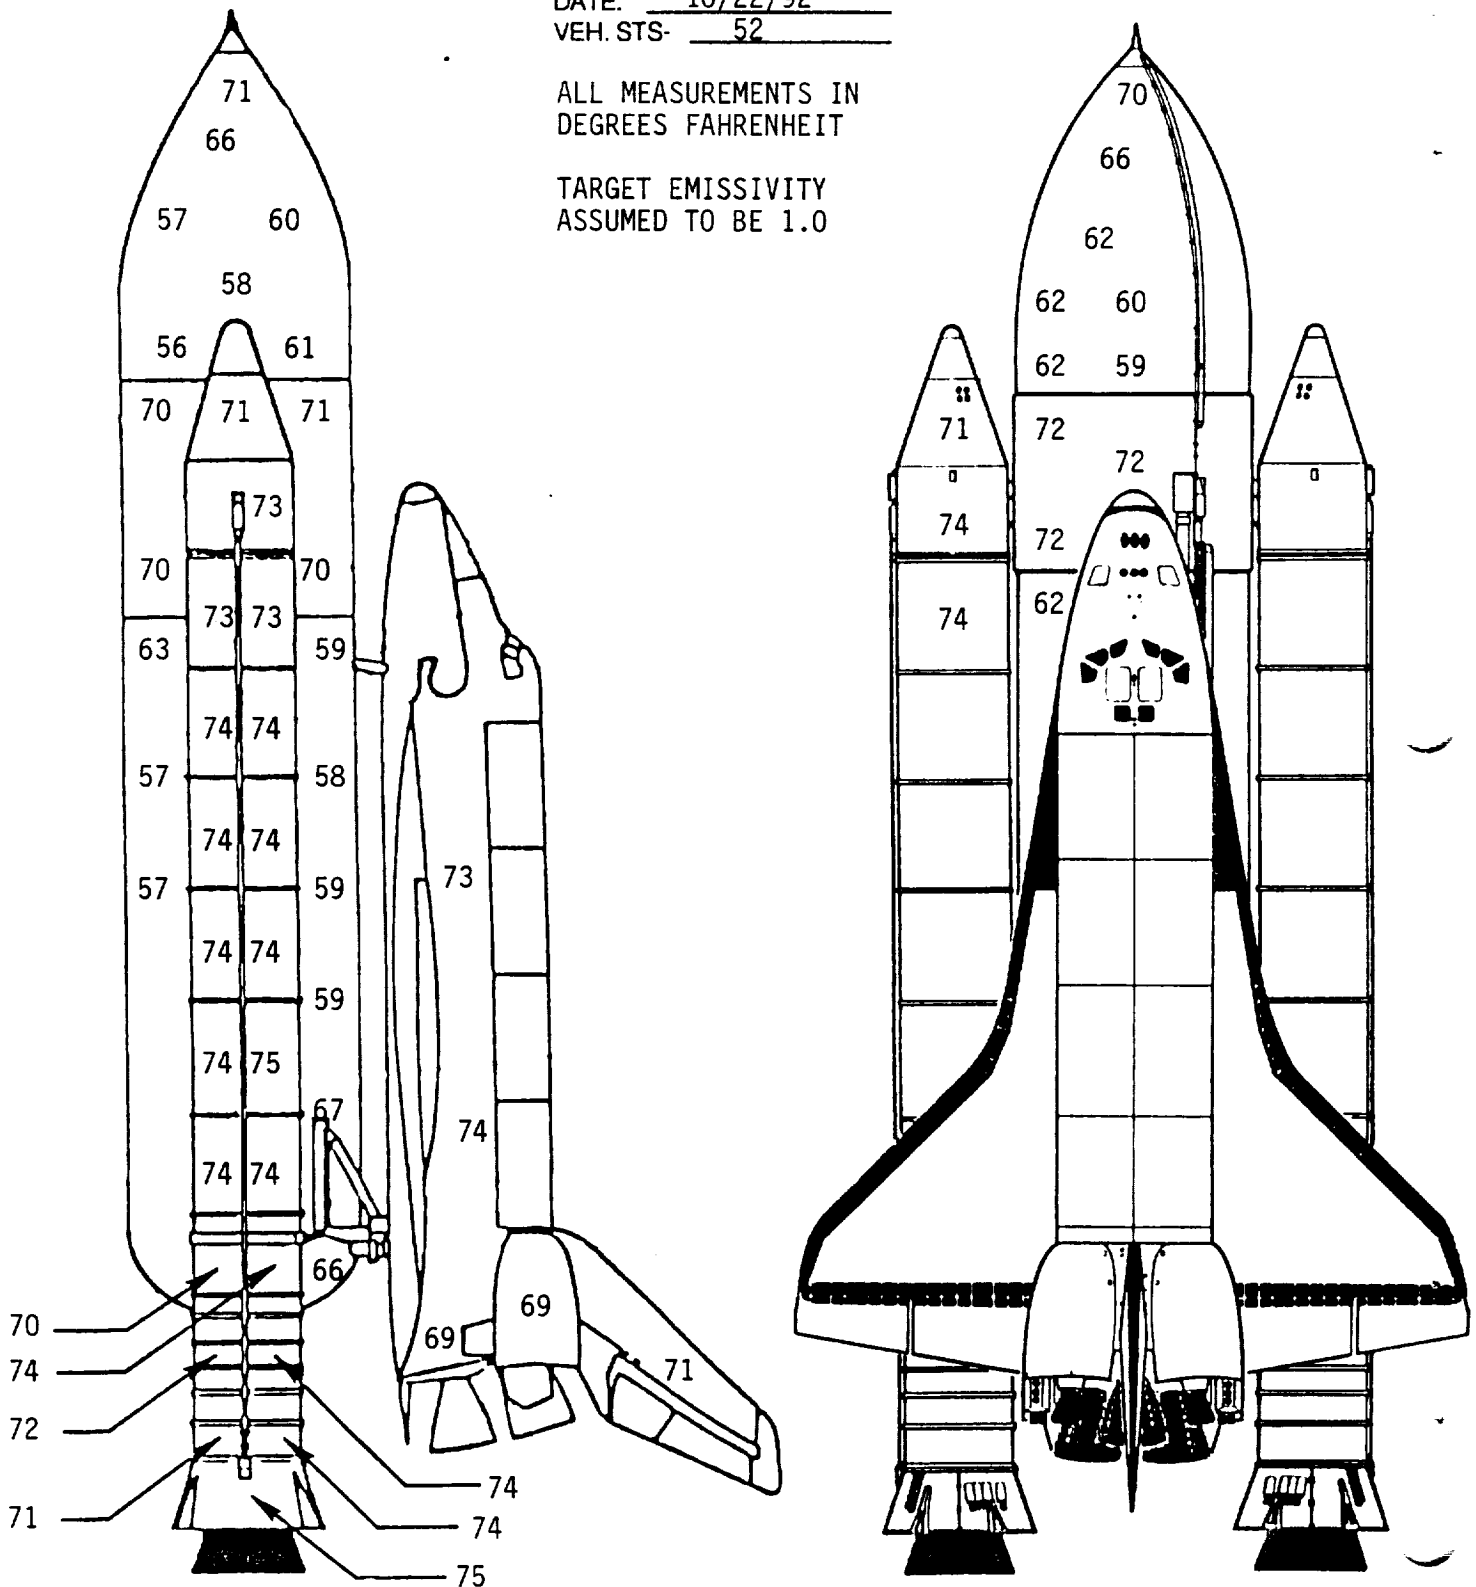
Figure 1. **SSV INFRARED SCANNER
SURFACE TEMPERATURE
SUMMARY DATA**

A portable Shuttle Thermal Imager (STI) infrared scanning radiometer was utilized to obtain vehicle surface temperature measurements for an overall thermal assessment of the vehicle, as shown in Figures 1 and 2.

No SRB anomalies or loose ablator/cork were observed. The K5NA closeouts of the aft booster stiffener ring splice plates were intact. The STI portable infrared scanner recorded RH and LH SRB case temperatures between 68 and 75 degrees Fahrenheit (F). In comparison, temperatures measured by a hand-held Minolta/Land Cyclops spot radiometer ranged from 67 to 75 degrees F and the SRB Ground Environment Instrumentation (GEI) measured temperatures ranging from 72 to 75 degrees F. All measured temperatures were above the 34 degrees F minimum requirement. The predicted Propellant Mean Bulk Temperature (PMBT) supplied by MTI was 78 degrees F, which was within the required range of 44-86 degrees F.

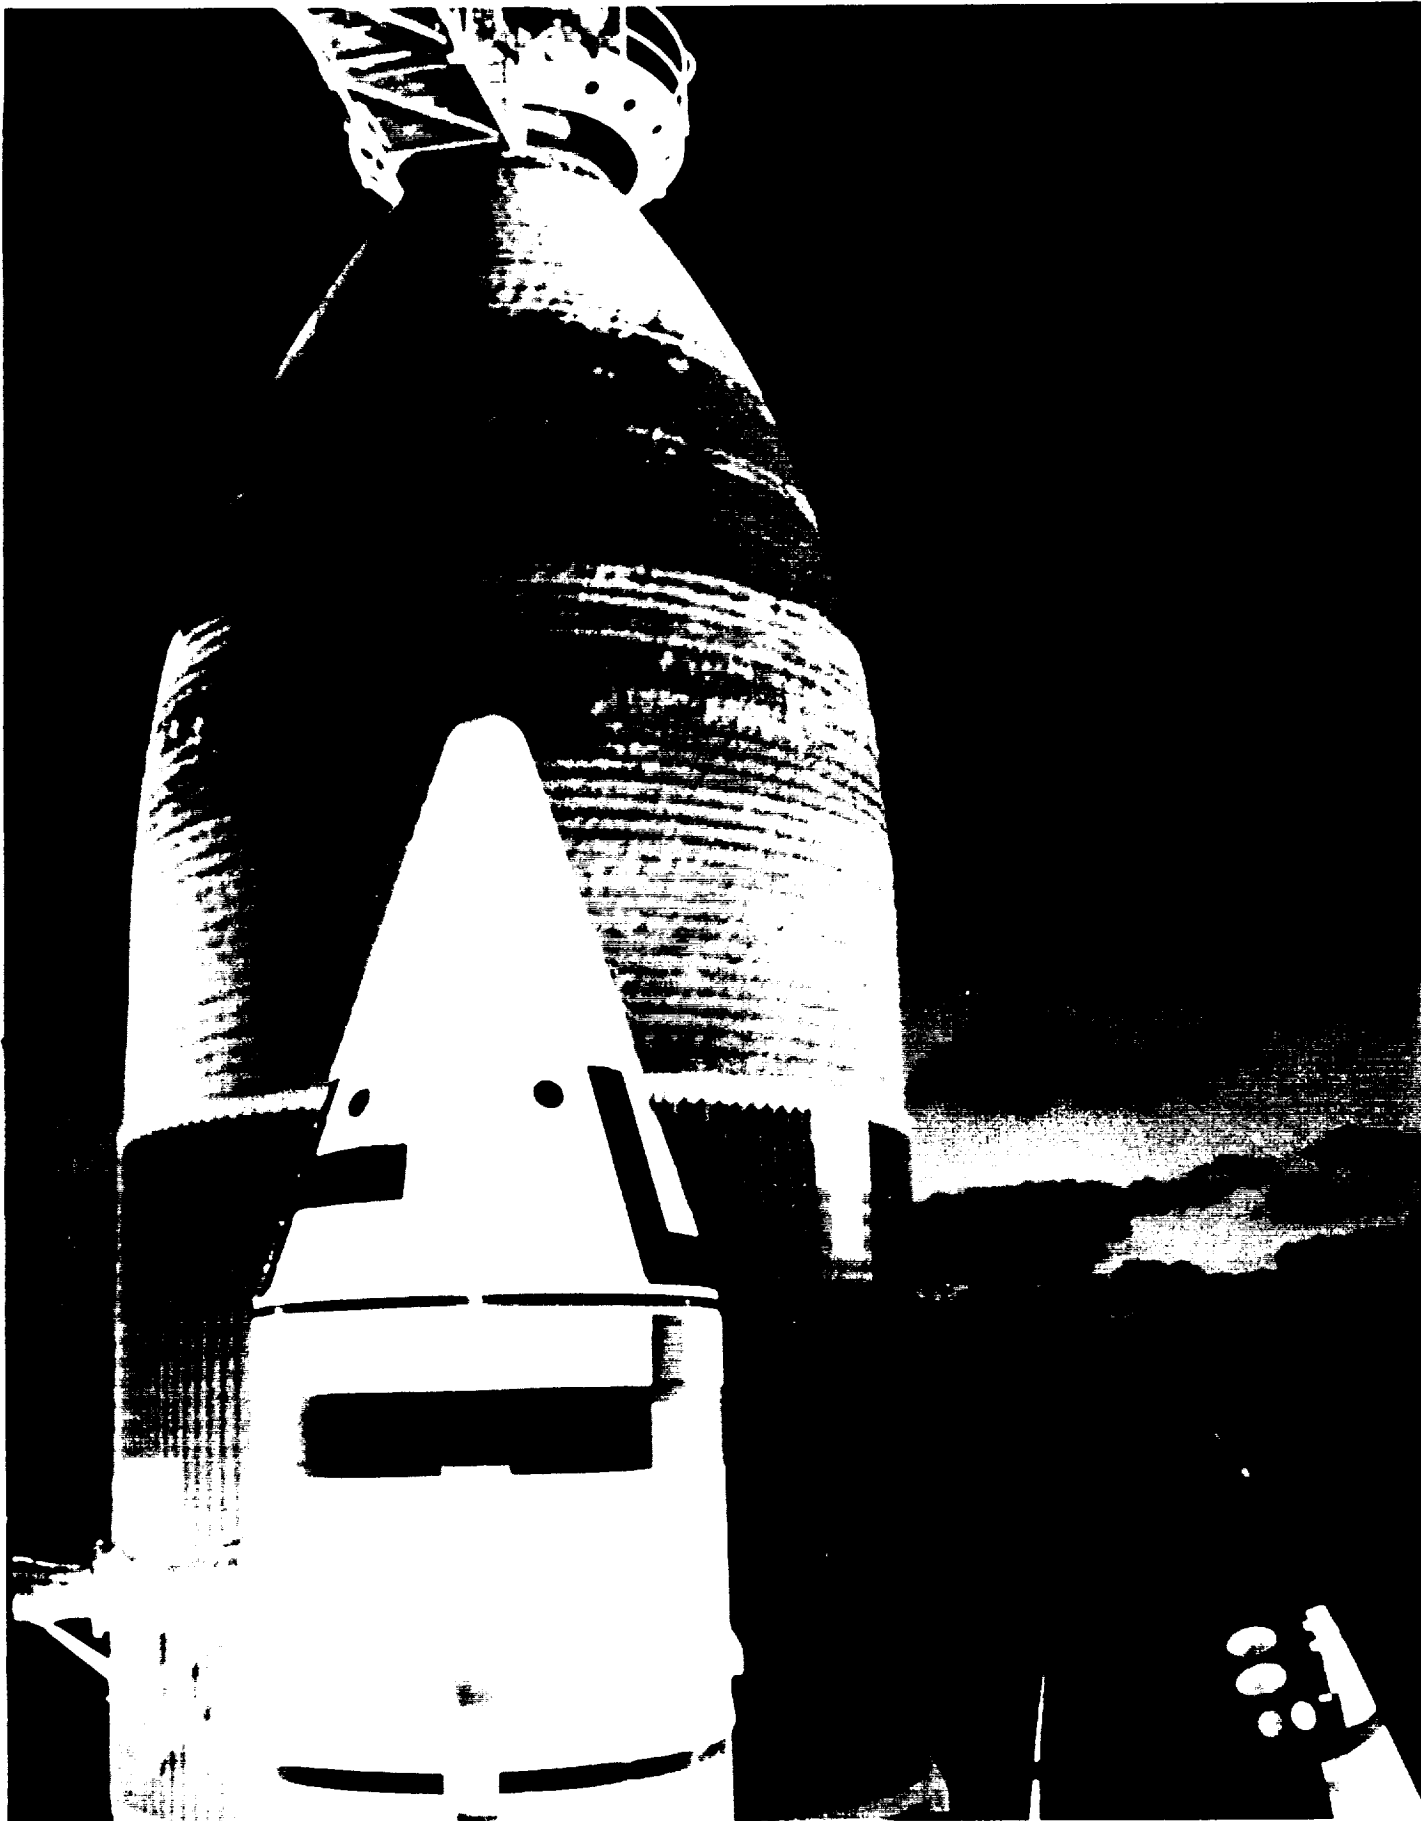
No condensate, ice, or frost accumulation was present on the
ET LO2 tank and intertank TPS acreage

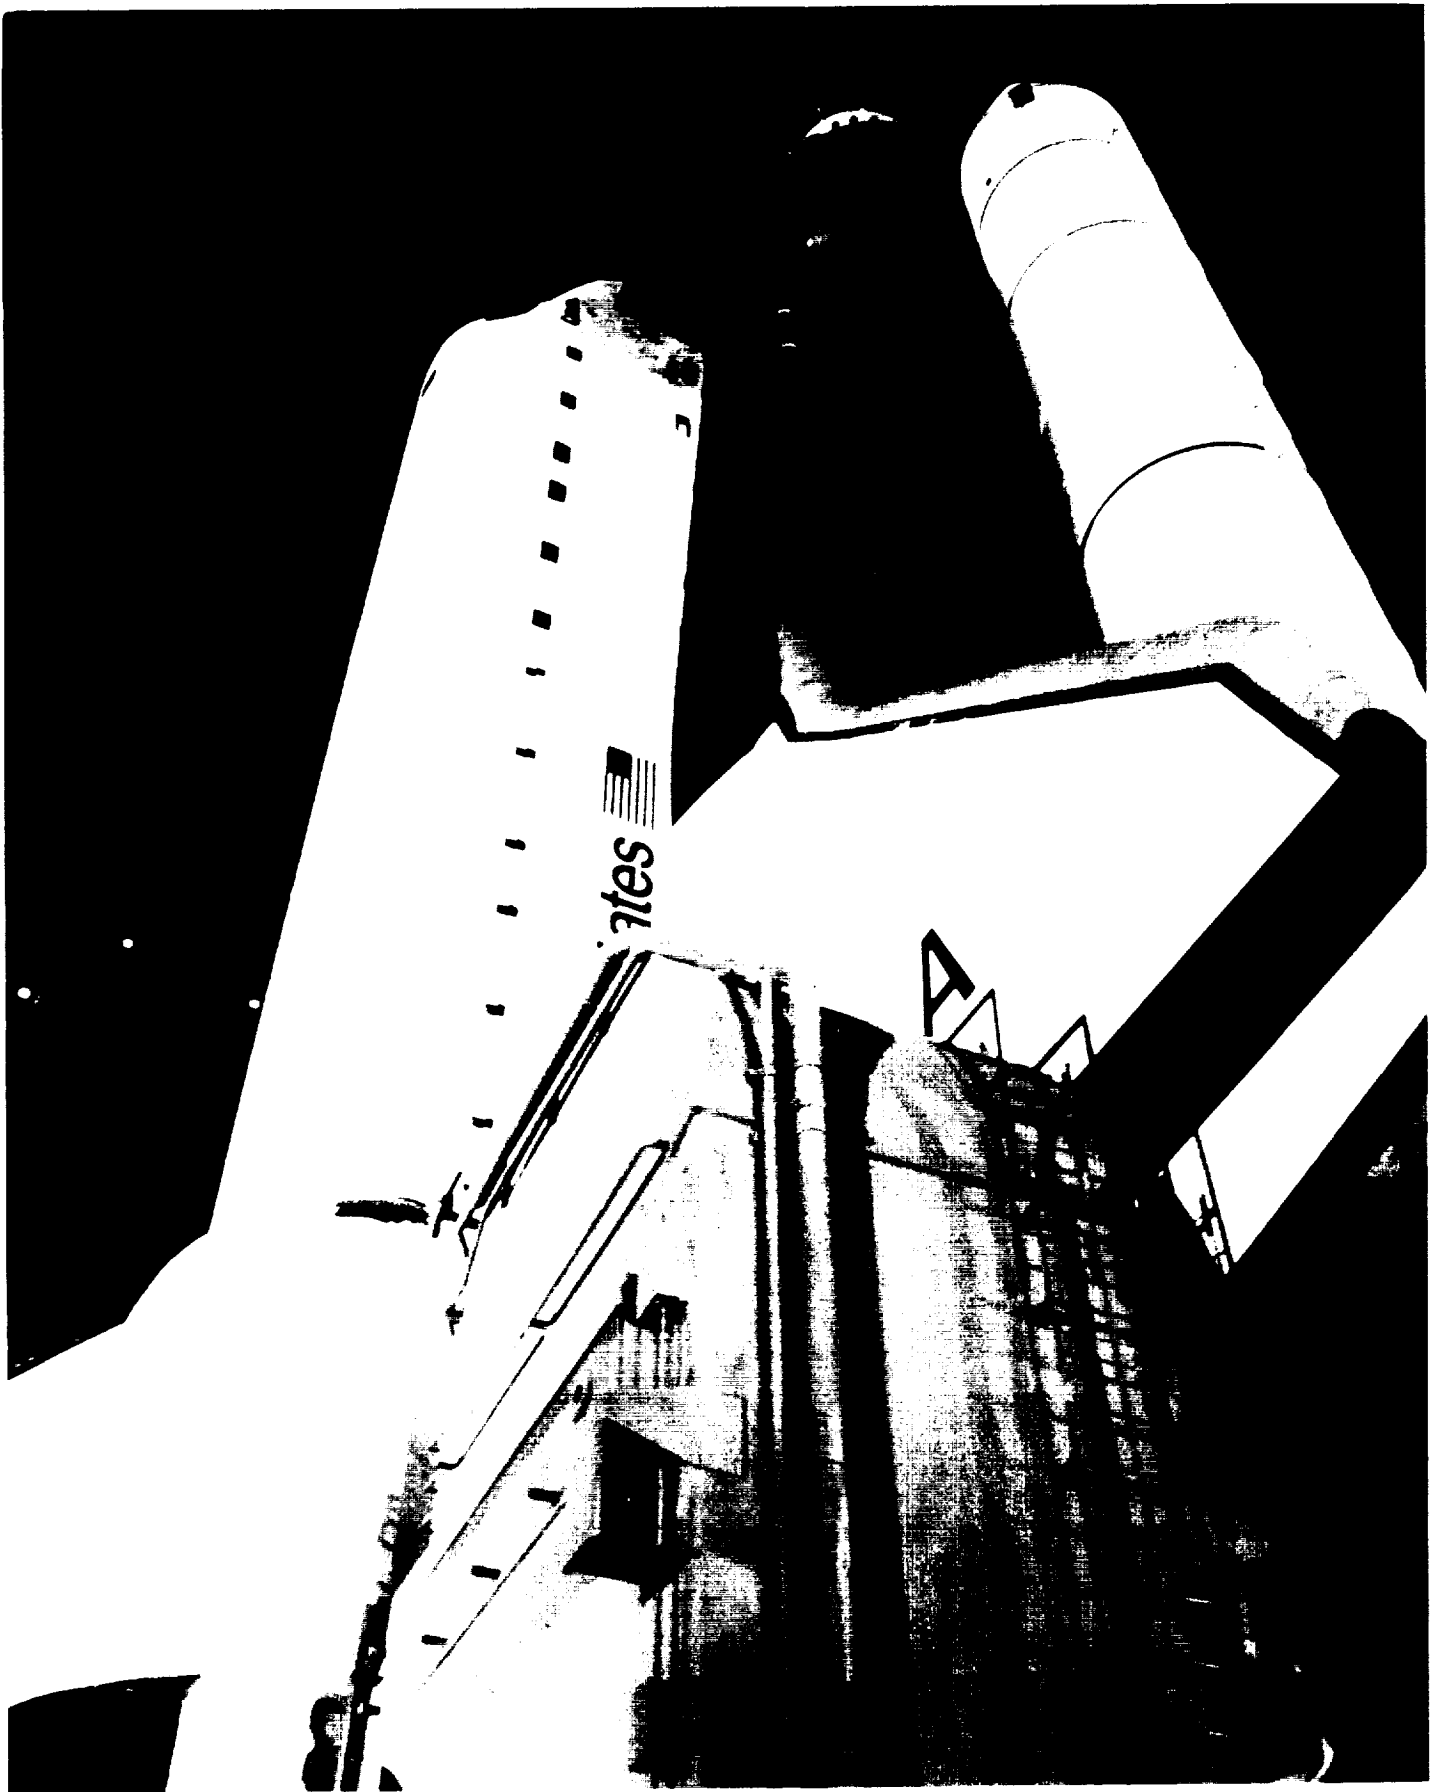
Light condensate, but no ice or frost accumulation, was present
on the LH2 tank acreage and aft dome

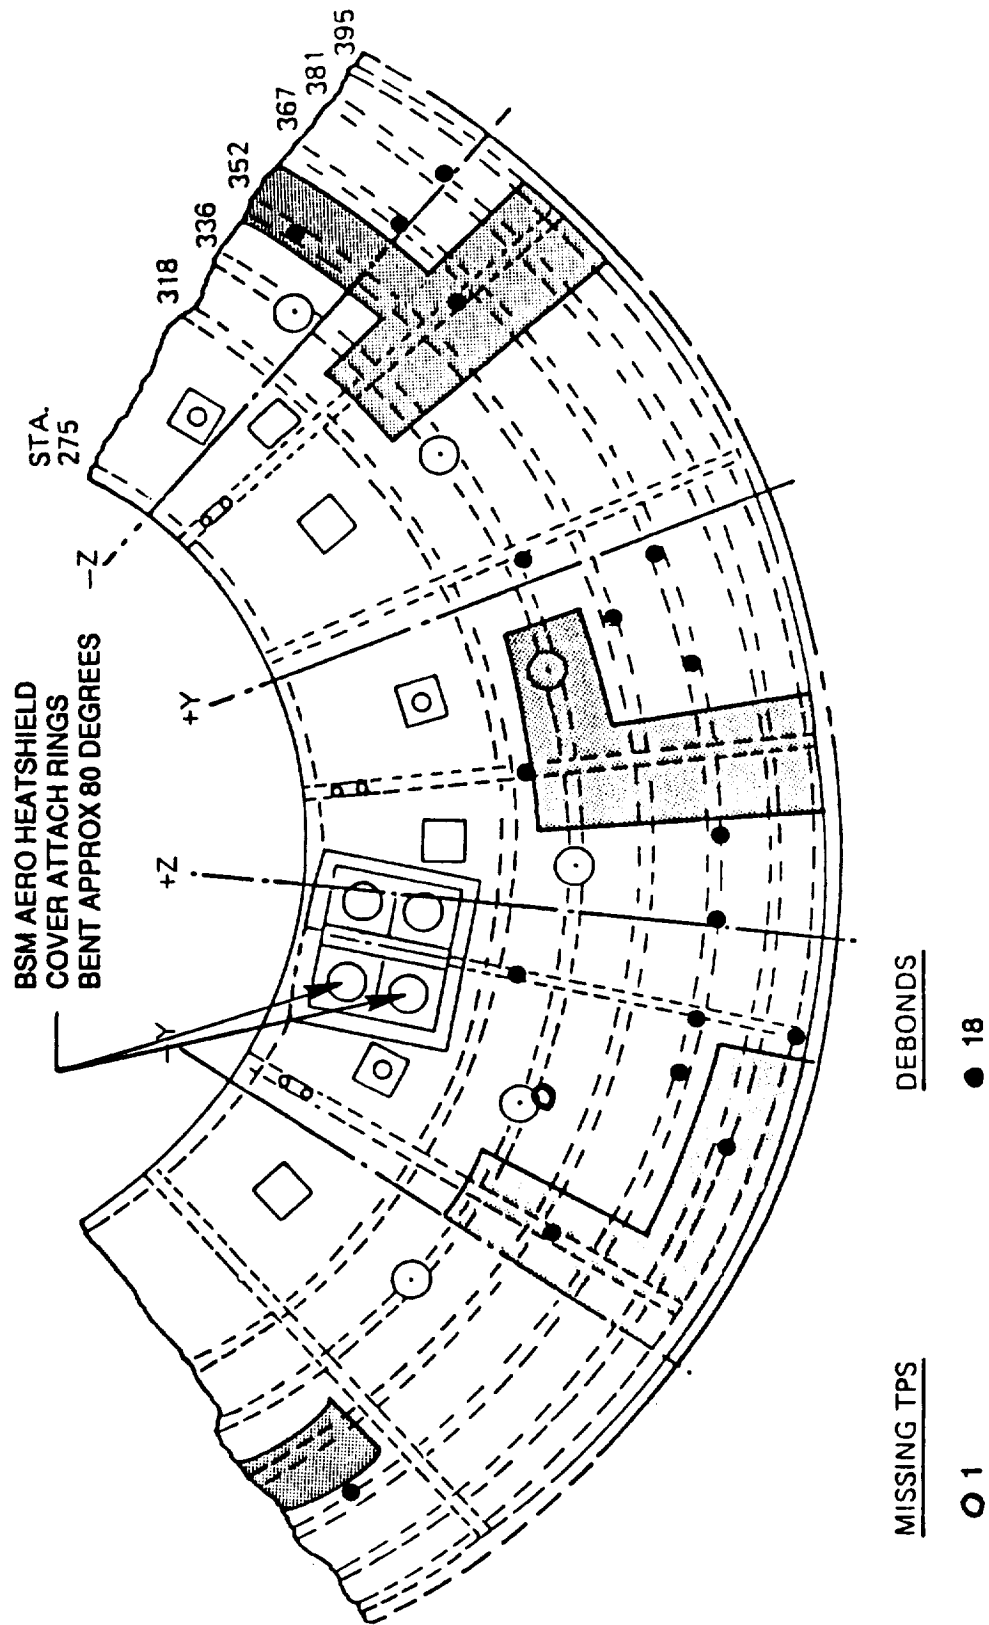
Figure 4. **RIGHT SRB FRUSTUM**

The RH frustum had 18 MSA-2 debonds over fasteners and one 1.5" diameter area of missing TPS in the -Y+Z quadrant at the 336 ring frame. Minor localized blistering of the Hypalon paint had occurred predominantly along the 395 ring (Figure 4). All BSM aero heat shield covers were locked in the fully opened position though the left two cover attach rings had been bent by parachute riser entanglement.

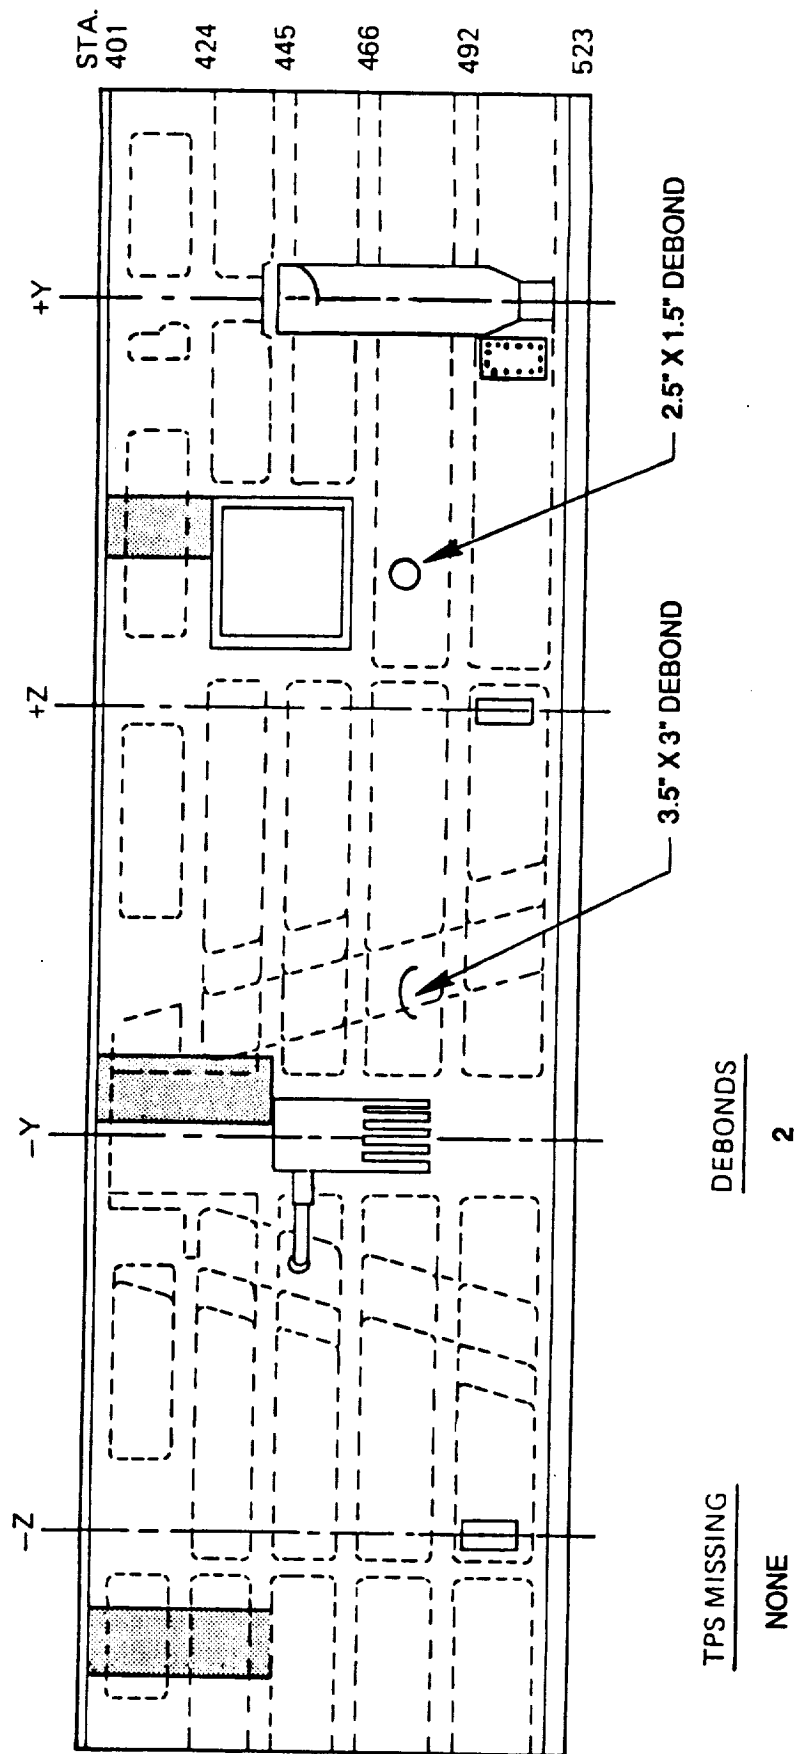
Figure 5. **RIGHT SRB FWD SKIRT**

The RH forward skirt exhibited no missing TPS, but did have two debonds. The first debond was located at approximately 240 degrees, station 480, and measured 3.5" x 3" in size. The second debond was located at approximately 150 degrees, station 470, and measured 2.5" x 1.5" in size. Both RSS antennae covers/phenolic base plates were intact and undamaged. Minor blistering of the Hypalon paint occurred on the forward ET/SRB attach point (Figure 5). No pins were missing from the frustum severance ring. The forward separation bolt and electrical cables appeared to have separated cleanly.

MINOR BLISTERING OF HYPALON
PAINT AT ET/SRB FORWARD
ATTACH POINT

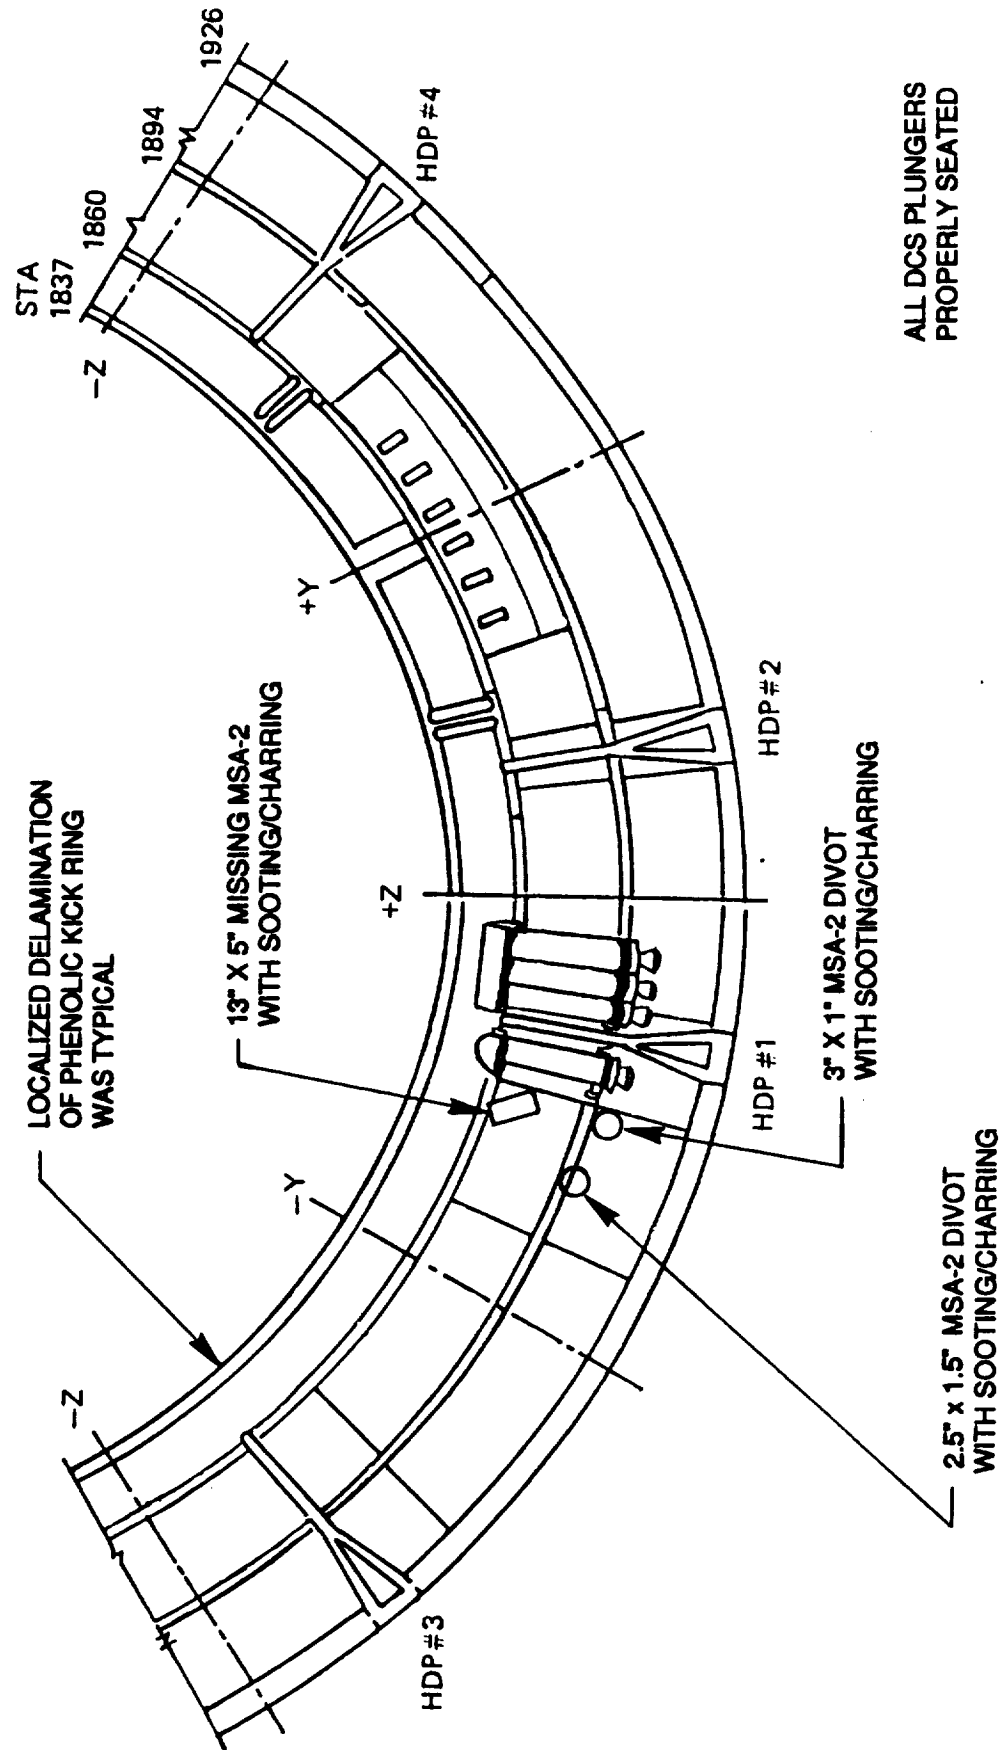
Figure 6. **RIGHT SRB AFT SKIRT EXTERIOR TPS**

The phenolic material on the kick ring was delaminated. Two divots, measuring 13" x 5" and 3" x 1", had occurred on the aft skirt acreage TPS just to the -Y side of the single BSM. Some of the material along the aft edge of the divots appeared sooted/charred. A third divot, measuring 2.5" x 1.5", had occurred between the single BSM and the -Y axis at station XB-1894 partially exposing two fastener head covers (Figure 6). Samples were taken from all three locations for laboratory analysis. K5NA was missing from all BSM nozzles.

Approximately 50 percent of the EPON shim was missing from HDP #3 aft skirt foot. The substrate was sooted/charred indicating that the shim material was lost prior to water impact. All Debris Containment System (DCS) plungers were seated properly. This was the eleventh flight utilizing the optimized link.

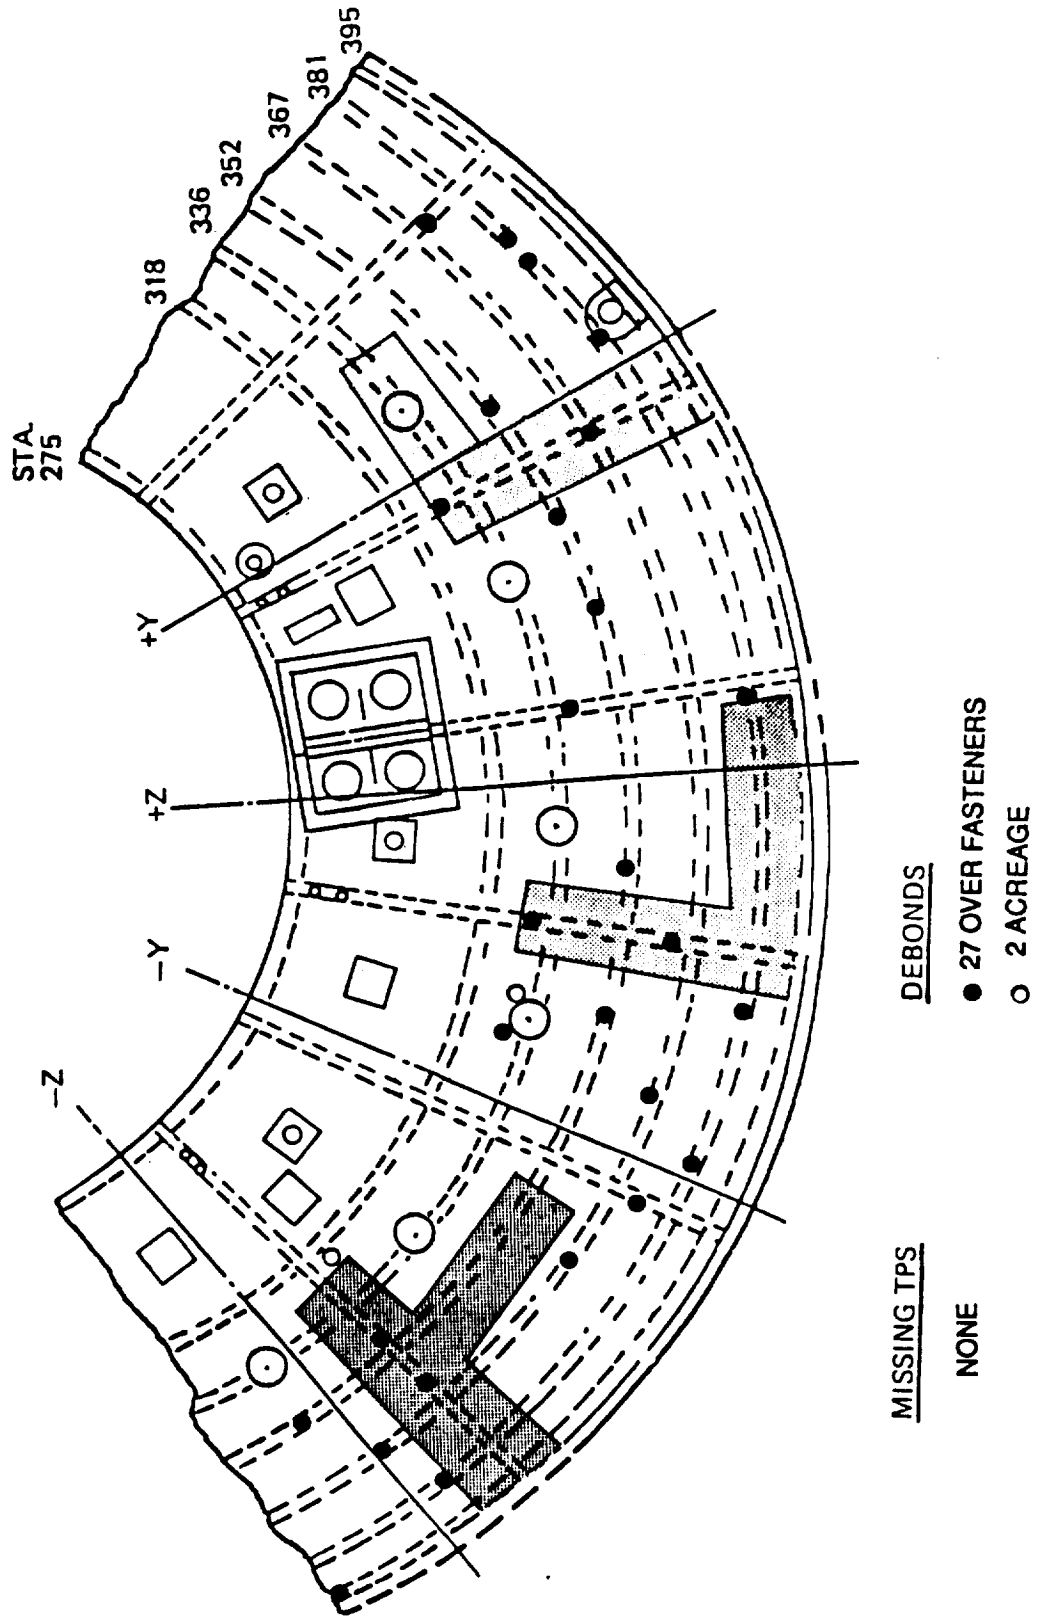
Figure 7. LEFT SRB FRUSTUM

The LH frustum was missing no TPS, but had 27 MSA-2 debonds over fasteners and two MSA-2 acreage debonds. There was minor localized blistering of the Hypalon paint along the 395 ring frame (Figure 7). The BSM aero heatshield covers were locked in the fully opened position.

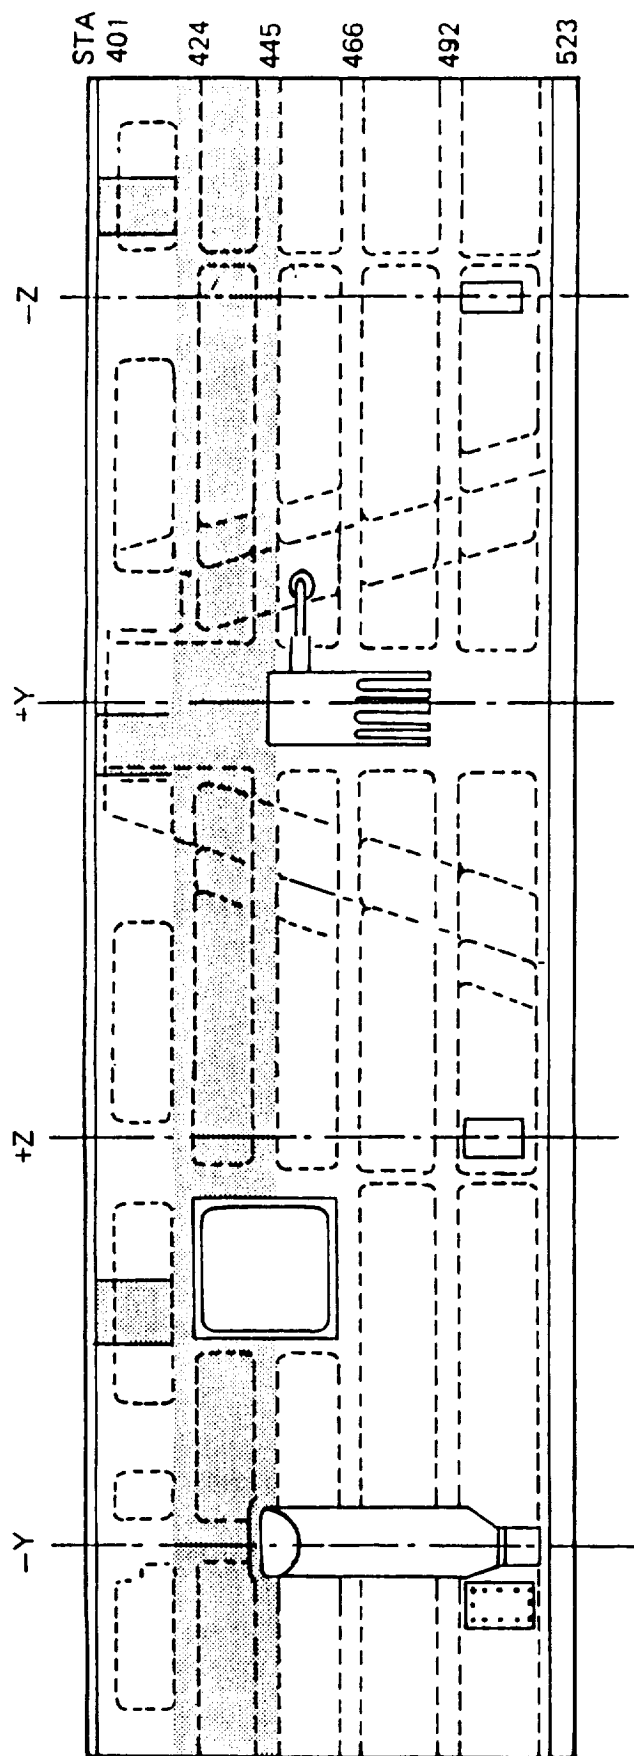
Figure 8. **LEFT SRB FWD SKIRT**

The LH forward skirt exhibited no debonds or missing TPS. The phenolic plates on both RSS antennae were intact and undamaged (Figure 8). The forward separation bolt and electrical cables appeared to have separated cleanly. No pins were missing from the frustum severance ring. Minor blistering of the Hypalon paint occurred near the ET/SRB attach point.

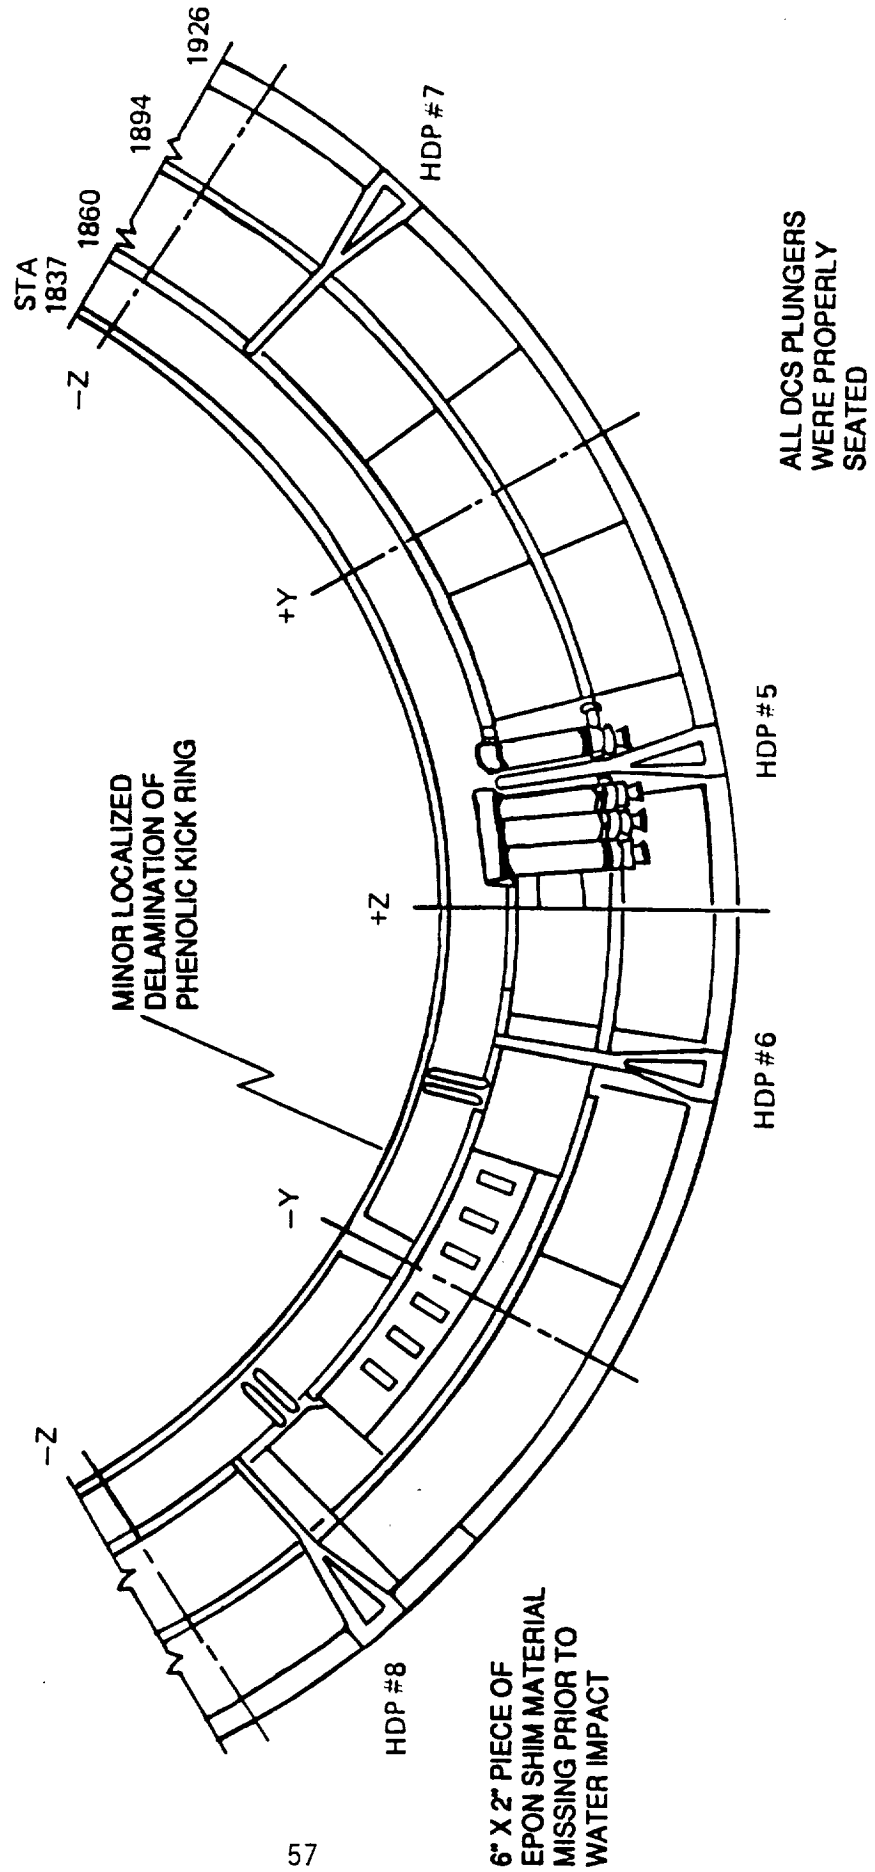
Figure 9. LEFT SRB AFT SKIRT EXTERIOR TPS

The phenolic material on the kick ring exhibited localized delamination. The acreage TPS on the aft skirt was generally in good condition (Figure 9).

A 6" x 2" piece of EPON shim was lost from HDP #8 aft skirt foot prior to water impact. All four Debris Containment System (DCS) plungers were properly seated. This was the eleventh flight utilizing the optimized link.

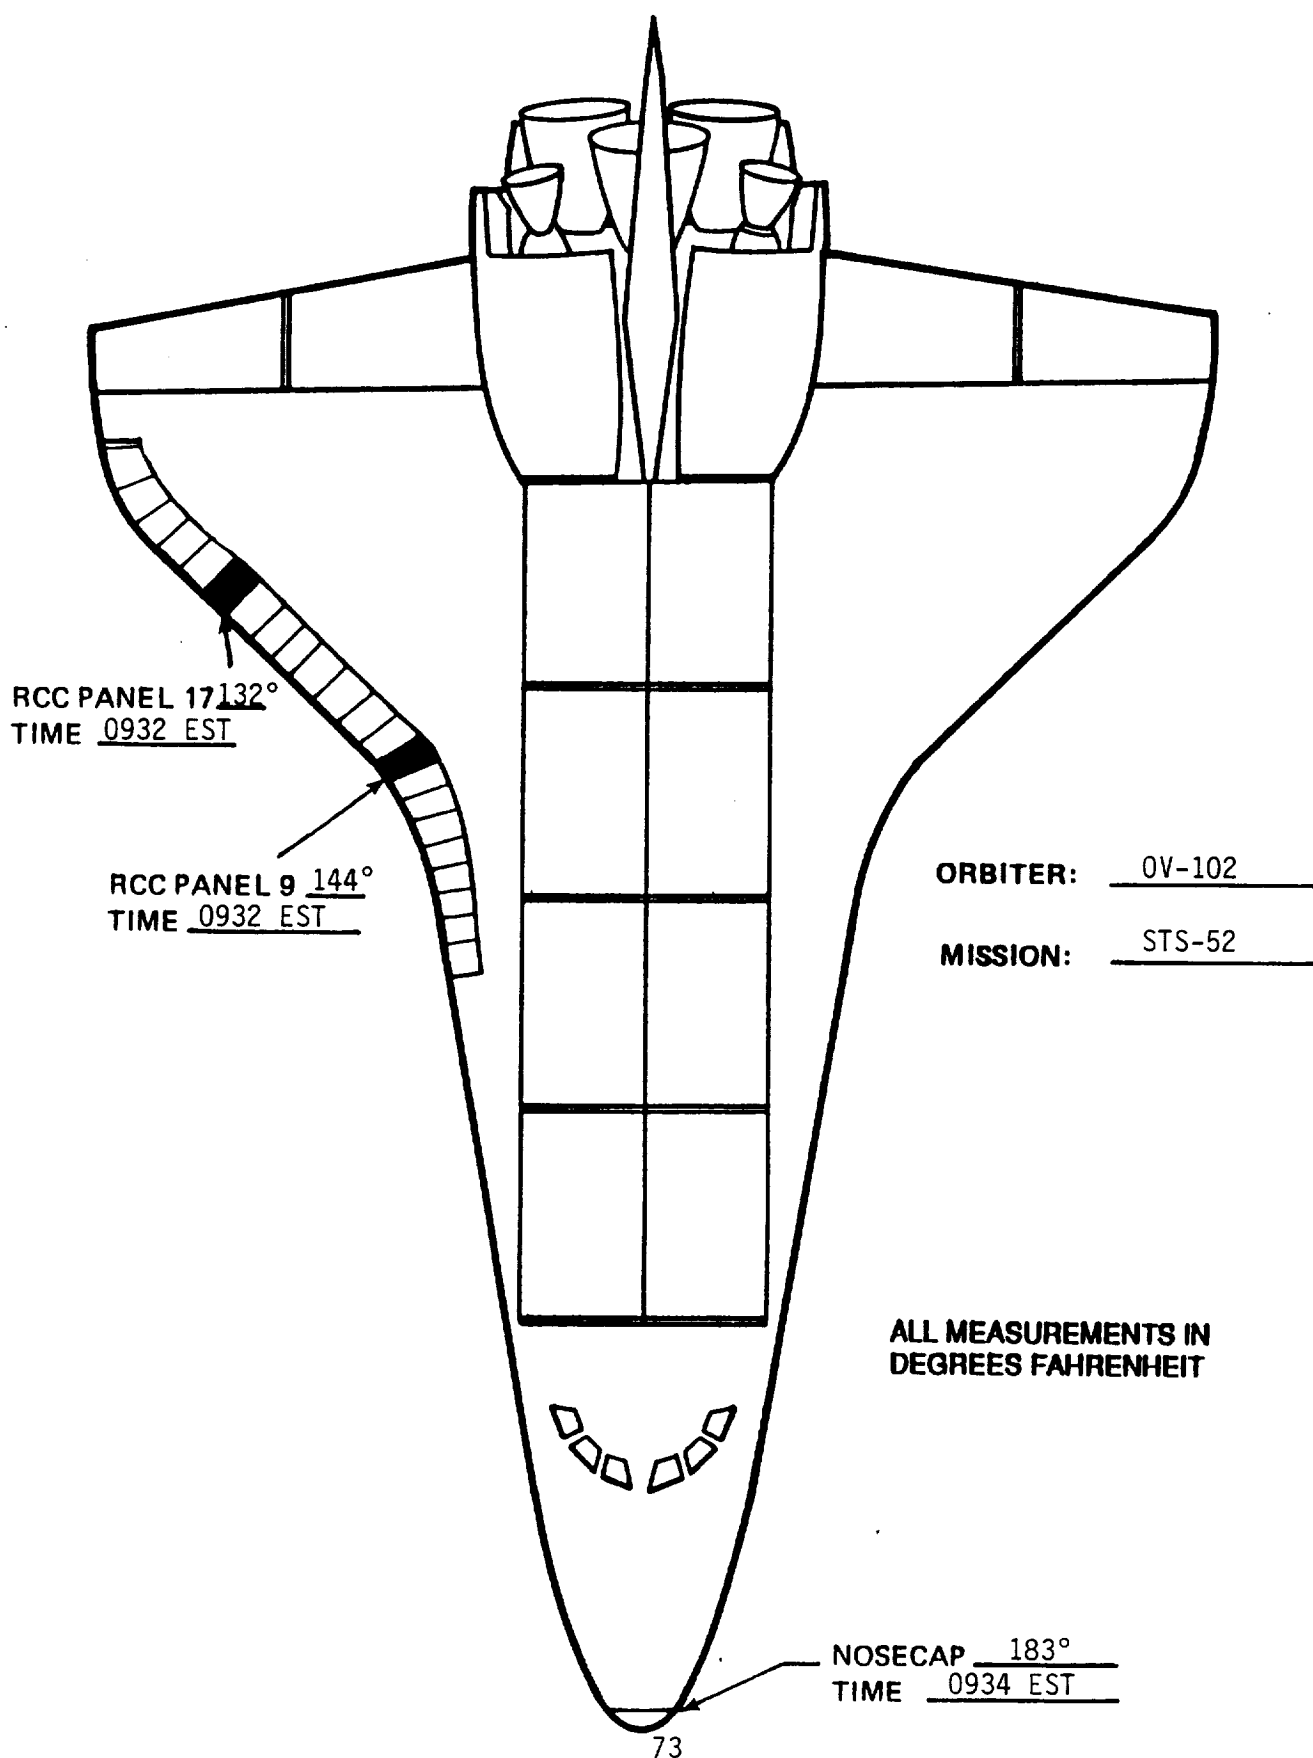
Figure 16. **STS-52 RCC TEMPERATURE MEASUREMENTS AS
RECORDED BY THE SHUTTLE THERMAL IMAGER**

A portable Shuttle Thermal Imager (STI) was used to measure the surface temperatures of three areas on the Orbiter (per OMRSD V09AJ0.095). Twenty-eight minutes after landing the Orbiter Reinforced Carbon-Carbon (RCC) nosecone was 183 degrees Fahrenheit (F). Twenty-six minutes after landing the RH wing leading edge RCC panel #9 was 144 degrees F, and panel #17 was 132 degrees F (reference Figure 16).

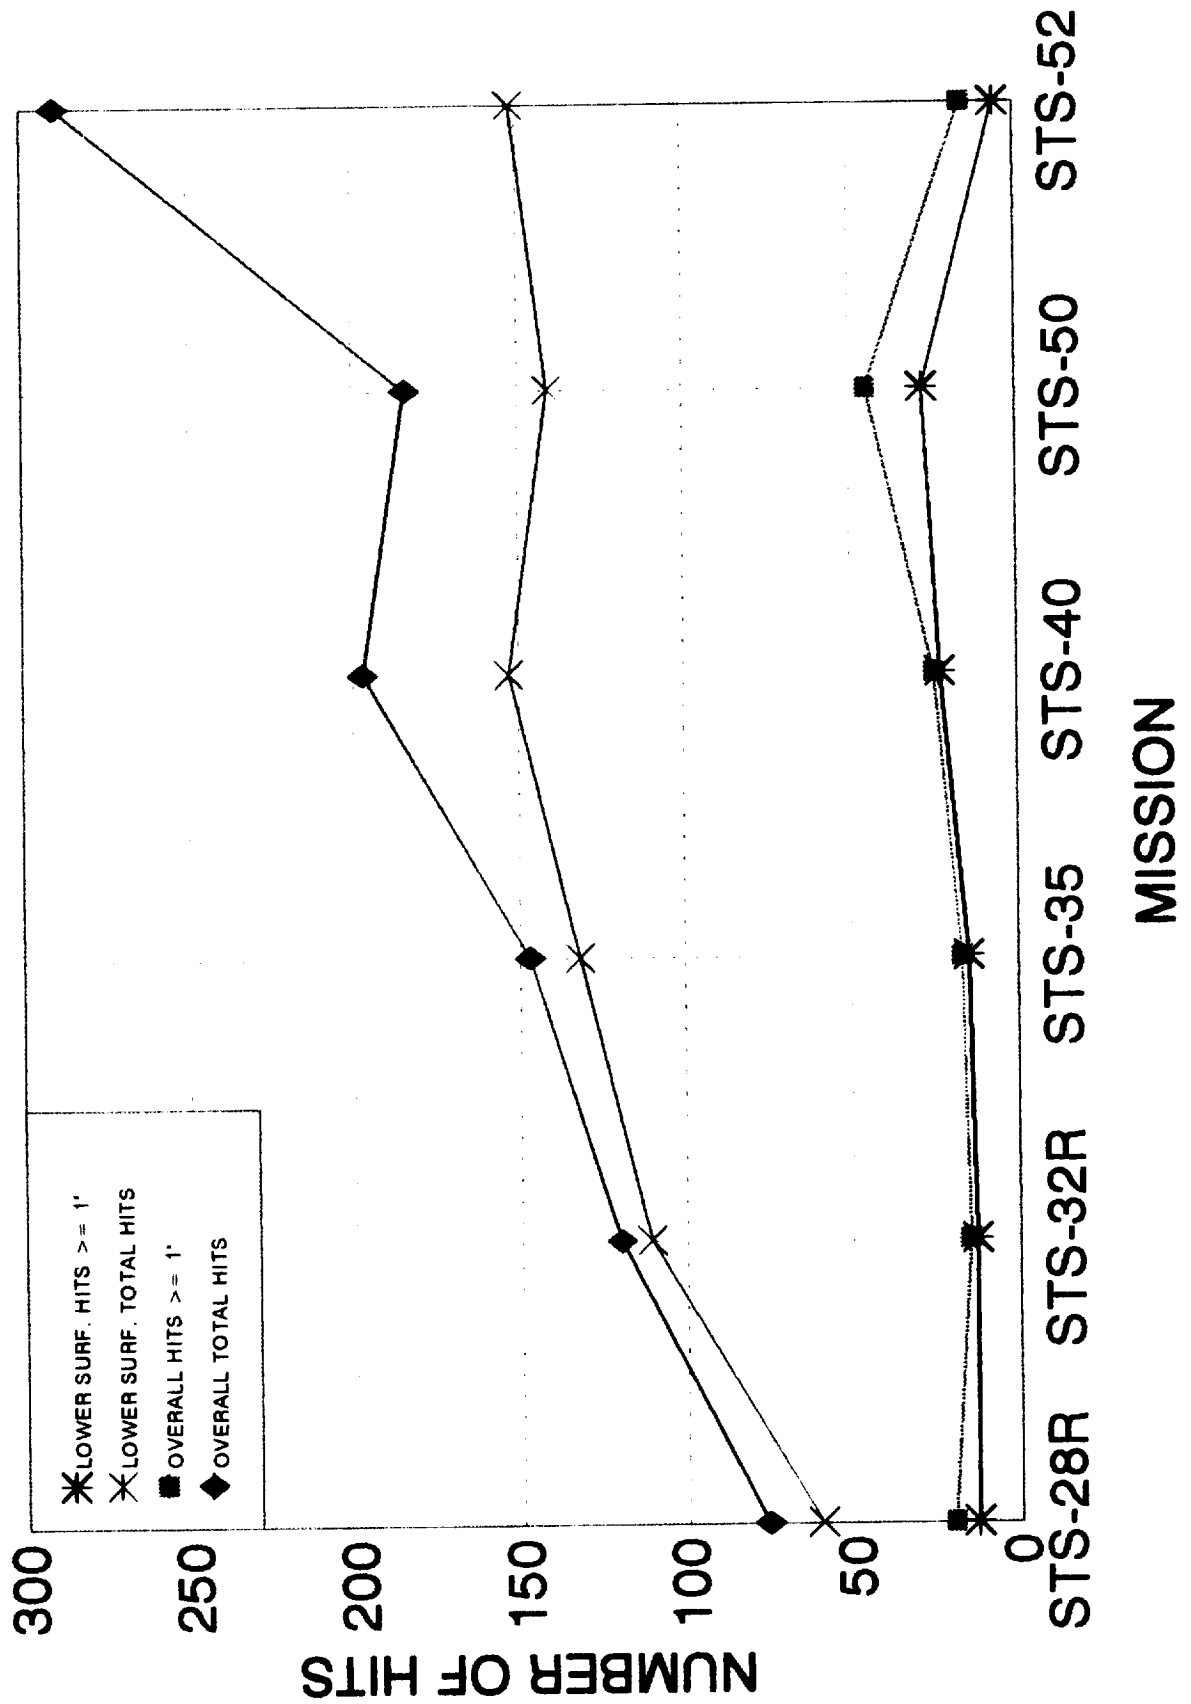
One factor that may be contributing to Orbiter debris damage is vehicle age. OV-102 has shown an increasing trend in the total number of debris hits sustained during each flight. This upward trend may be due to the effects of age on Orbiter TPS materials. Original and repaired TPS materials may become weak/loose due to the effects of thermal cycling and exposure to vibration/loading, creating potentially damaging debris. Post landing debris damage sustained by OV-102 during the last six flights is shown in Figure 20.
